# Cooke's Hollow

## Feasibility Study and Preliminary Design Report

Arlington, Massachusetts

August 2023

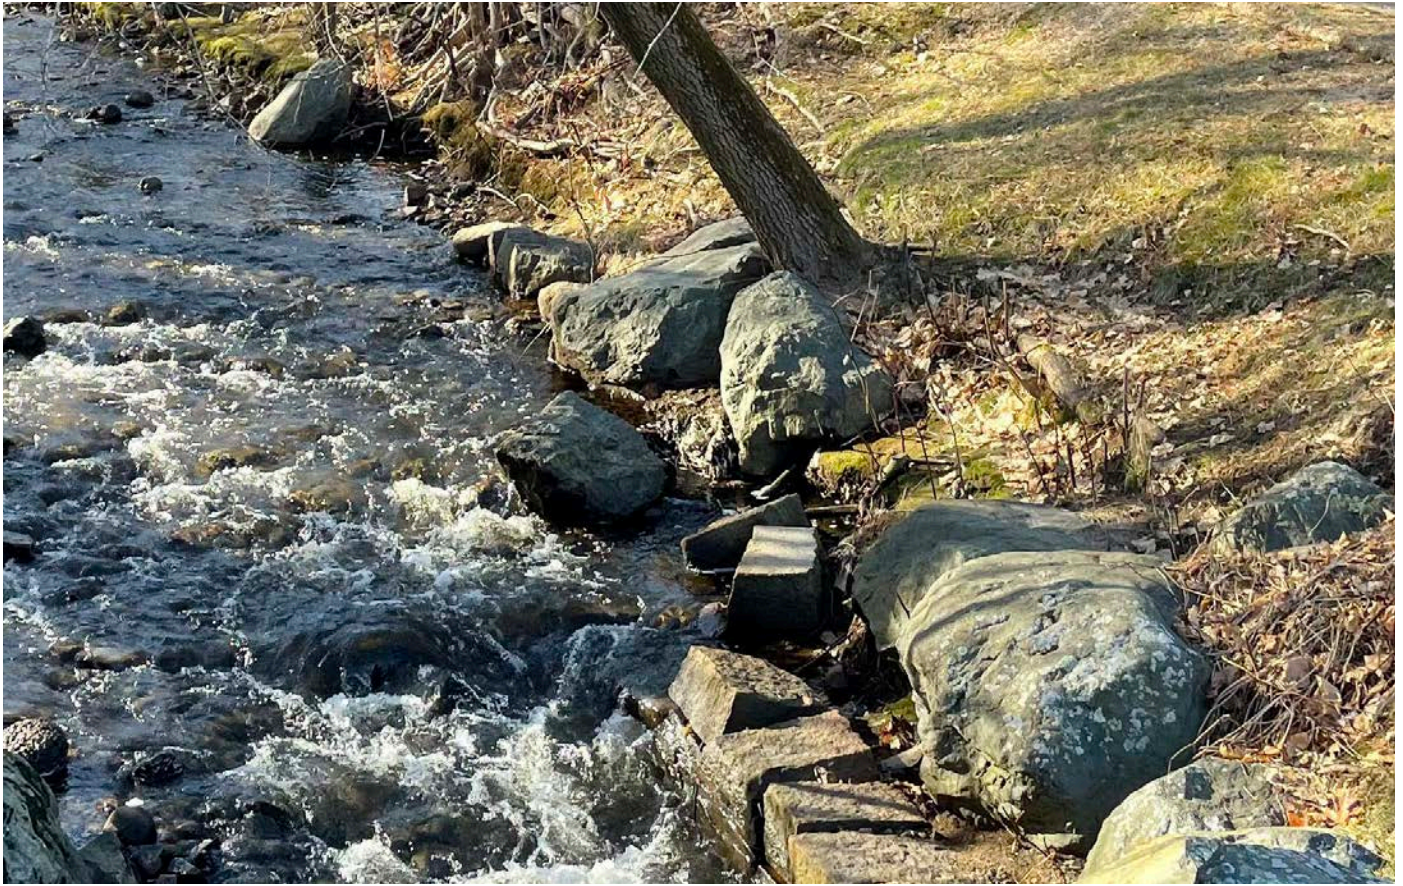
1 Boulder Edge Near Mystic Bridge

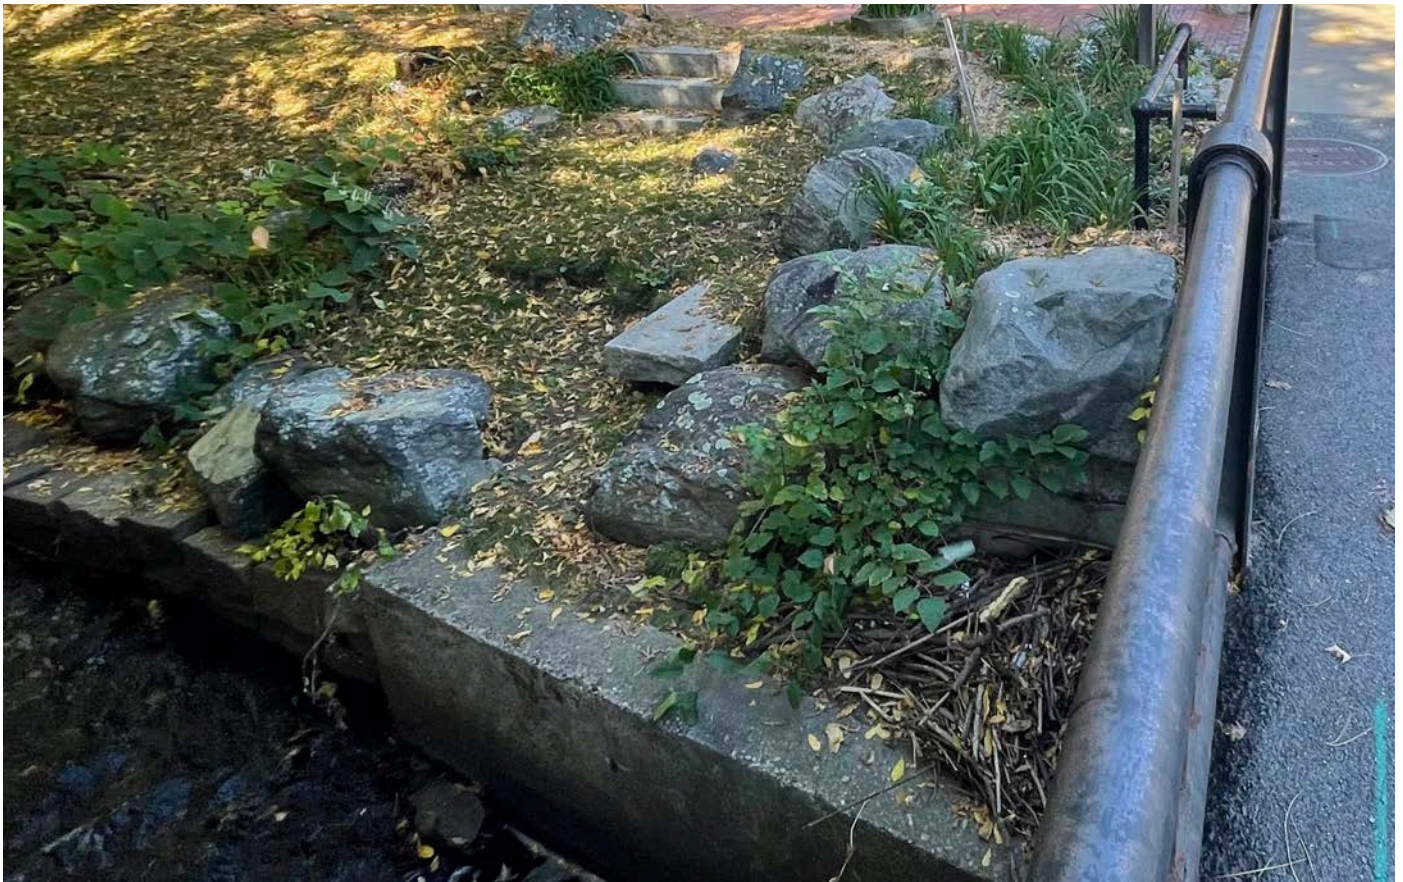
2 Boulder Edge Transitions to Concrete Abutment at Mystic Bridge

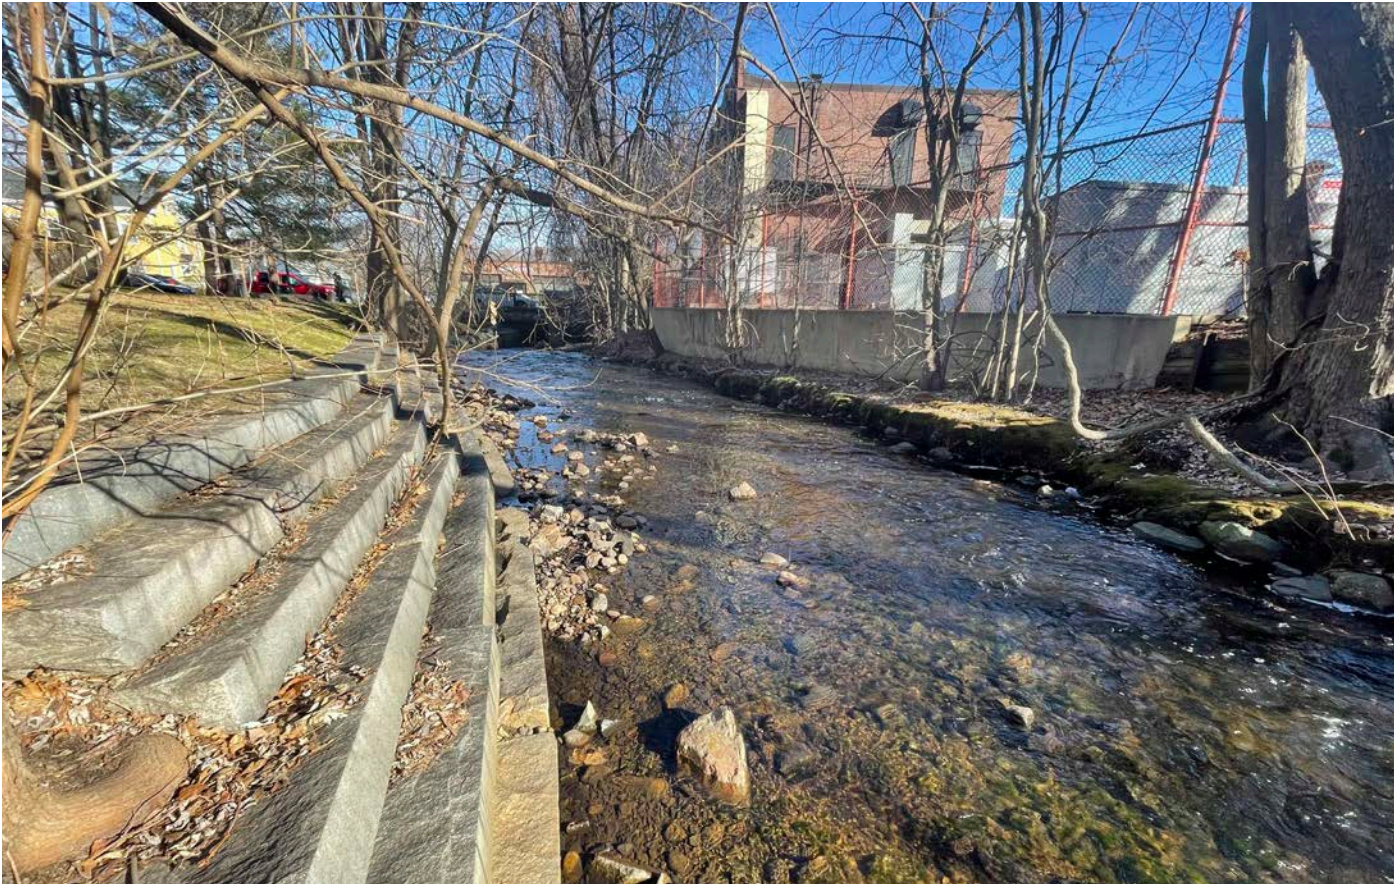
3 Stacked Granite Curb Edge (Looking Down Stream)

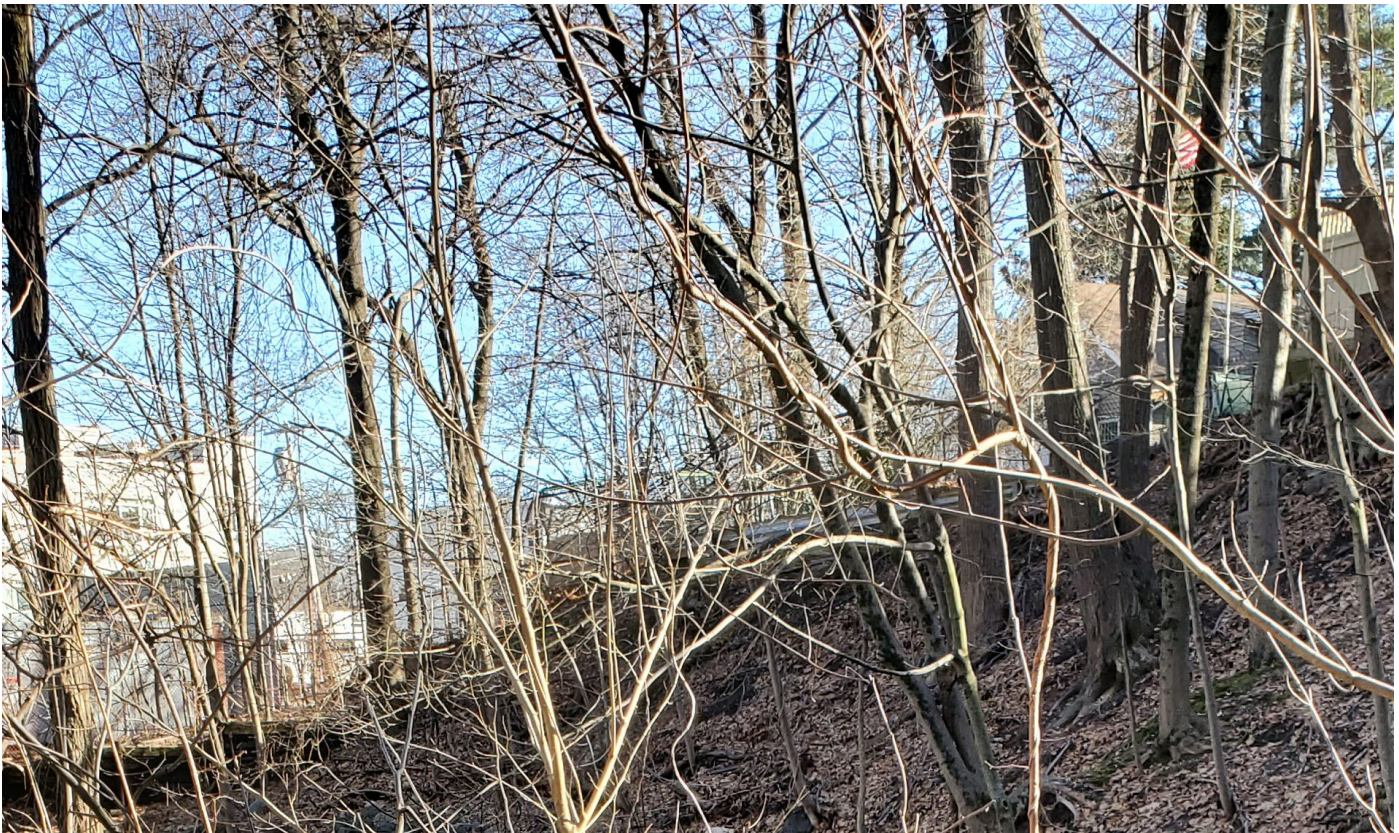
4 Norway Maple Dominated Southern Bank

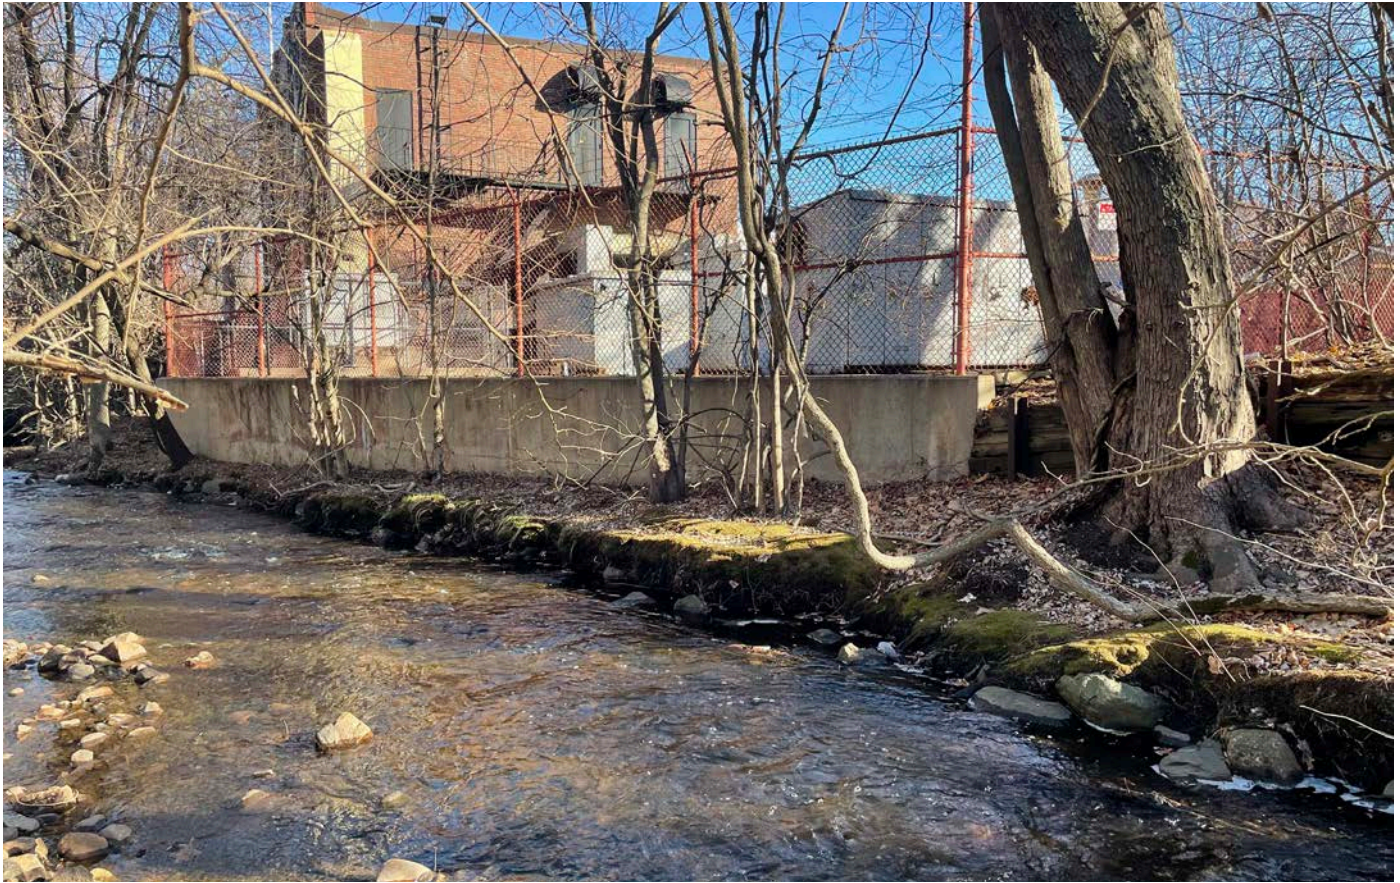
5 Natural Edge Southern Side

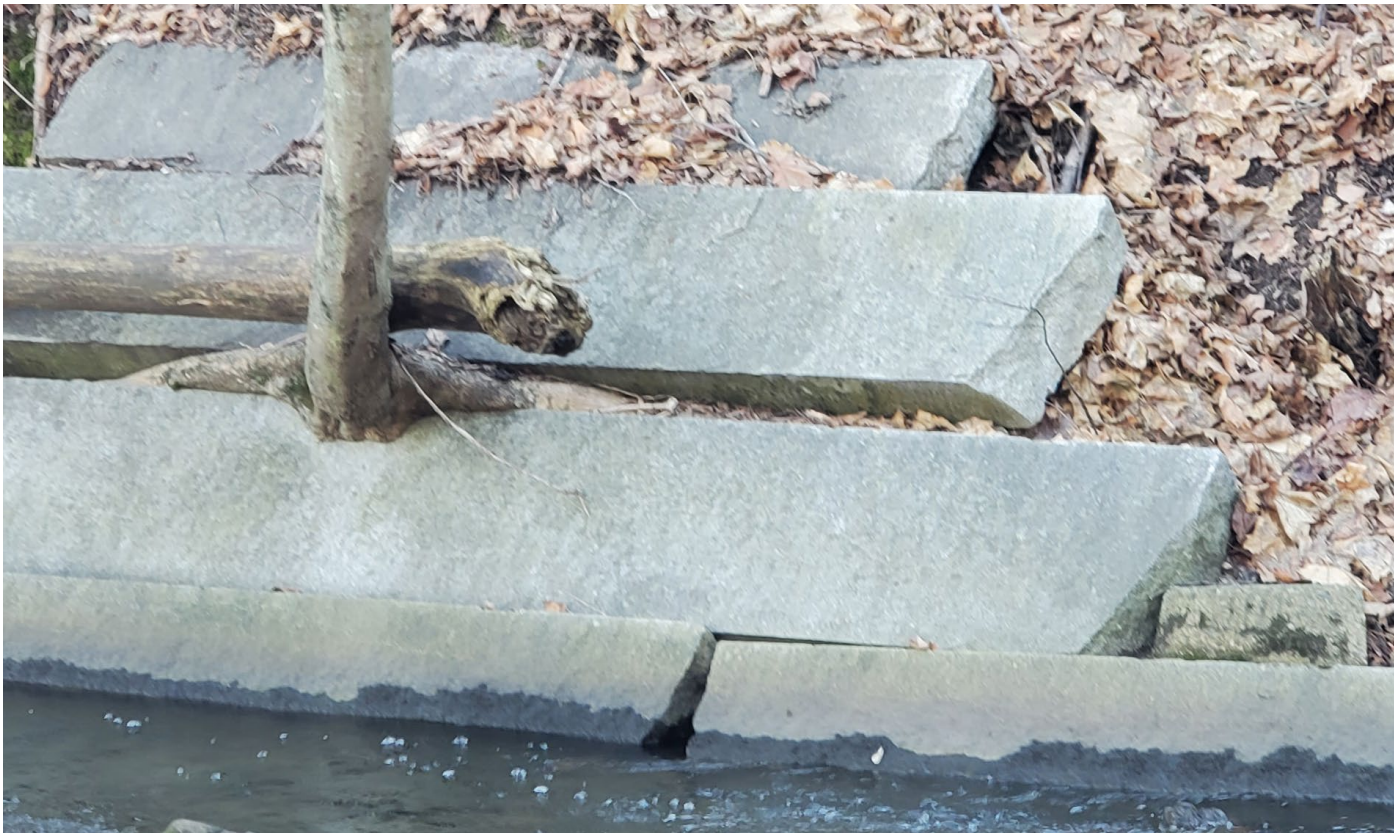
6 Stacked Granite Curb Armored Bank (North Side Near Falls)

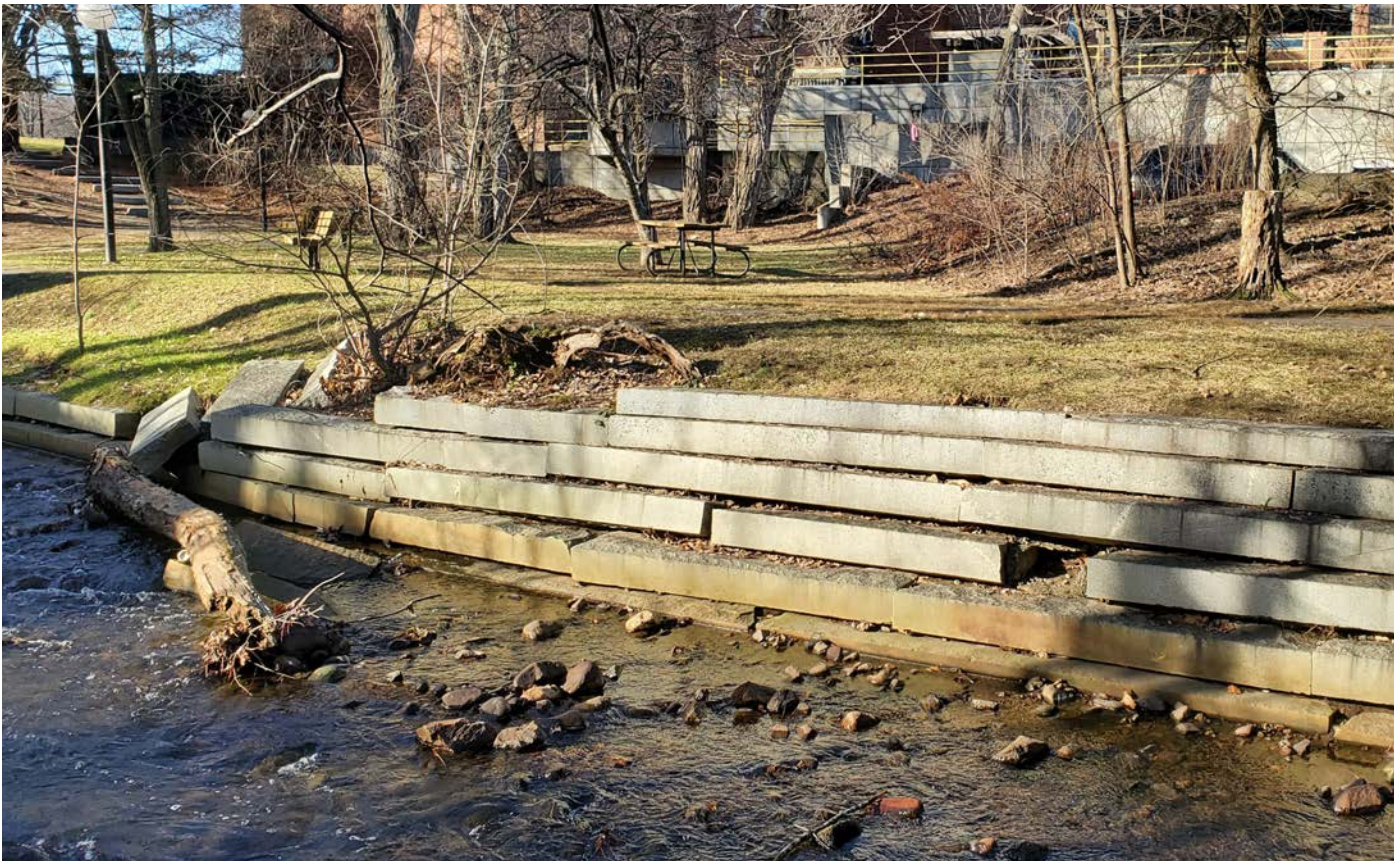
7 Stacked Granite Curb Armored Bank

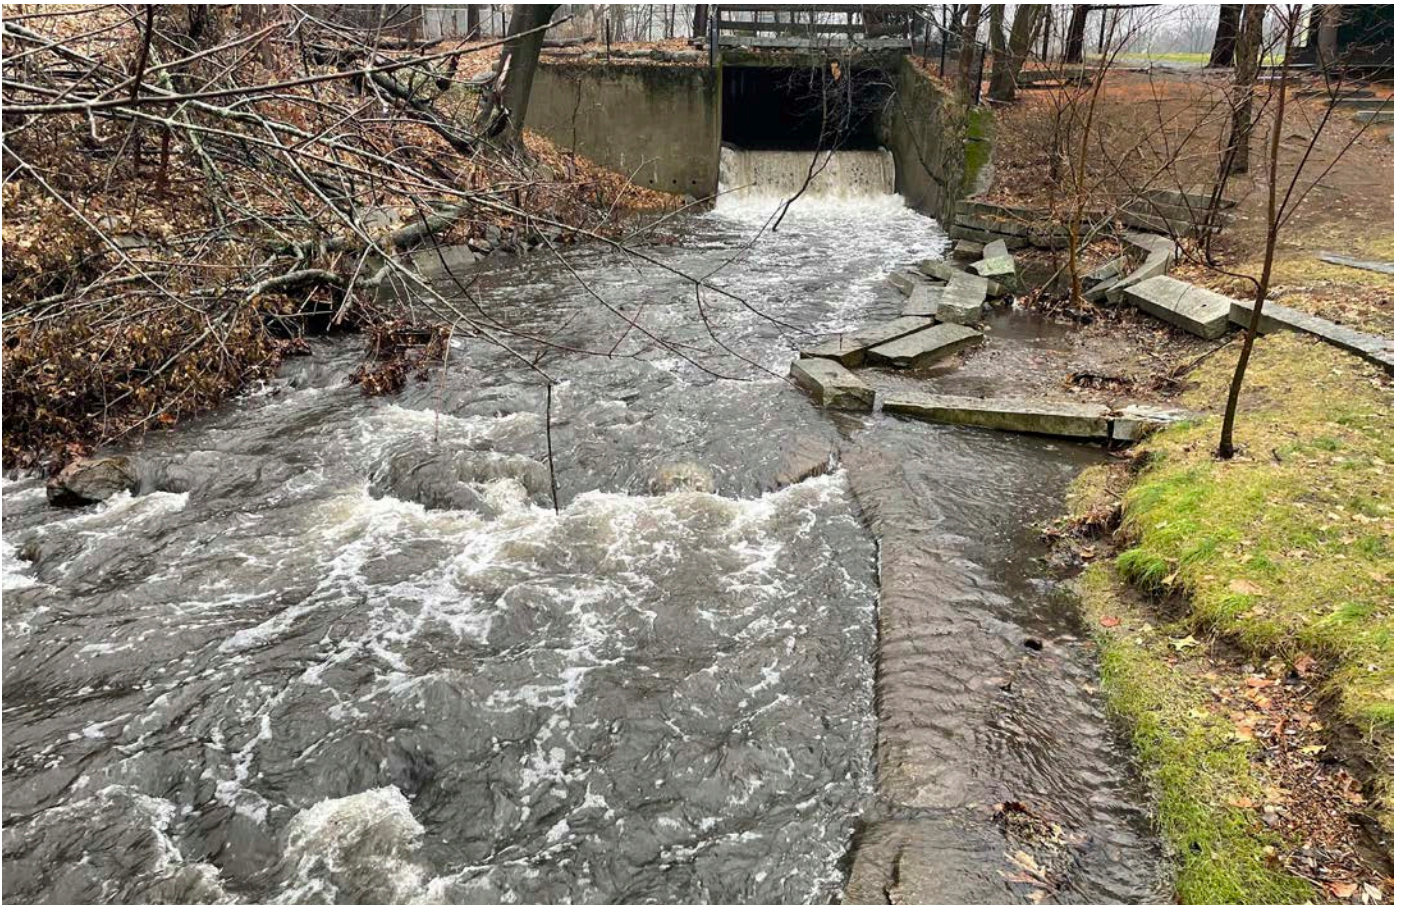
10 Falls During Moderate Flooding Conditions

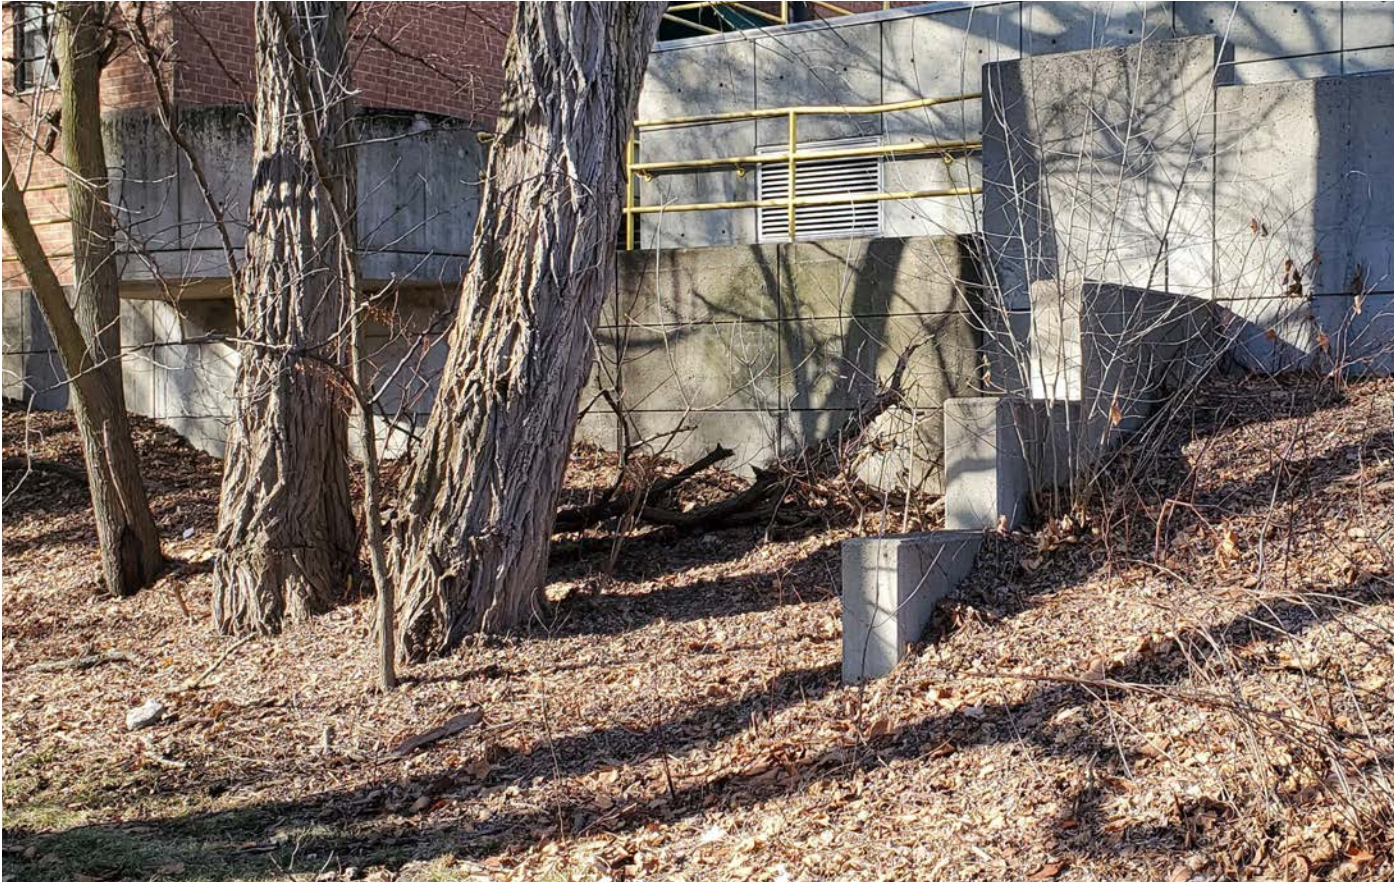
1 Cusack Terrace Retaining Wall Edge

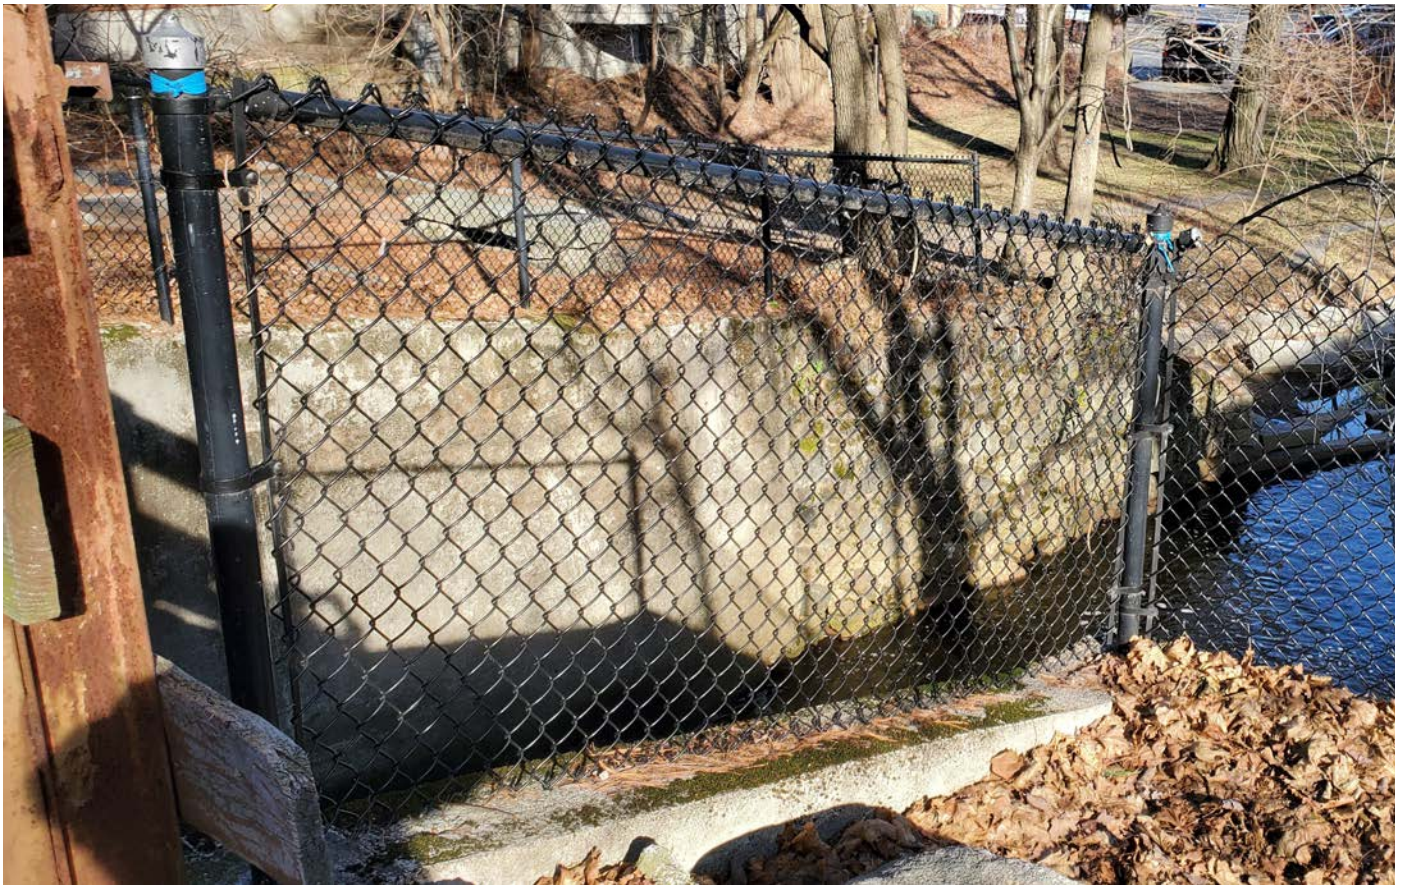
3 4' Black Vinyl Chain Link Fence Along Wall Above Falls

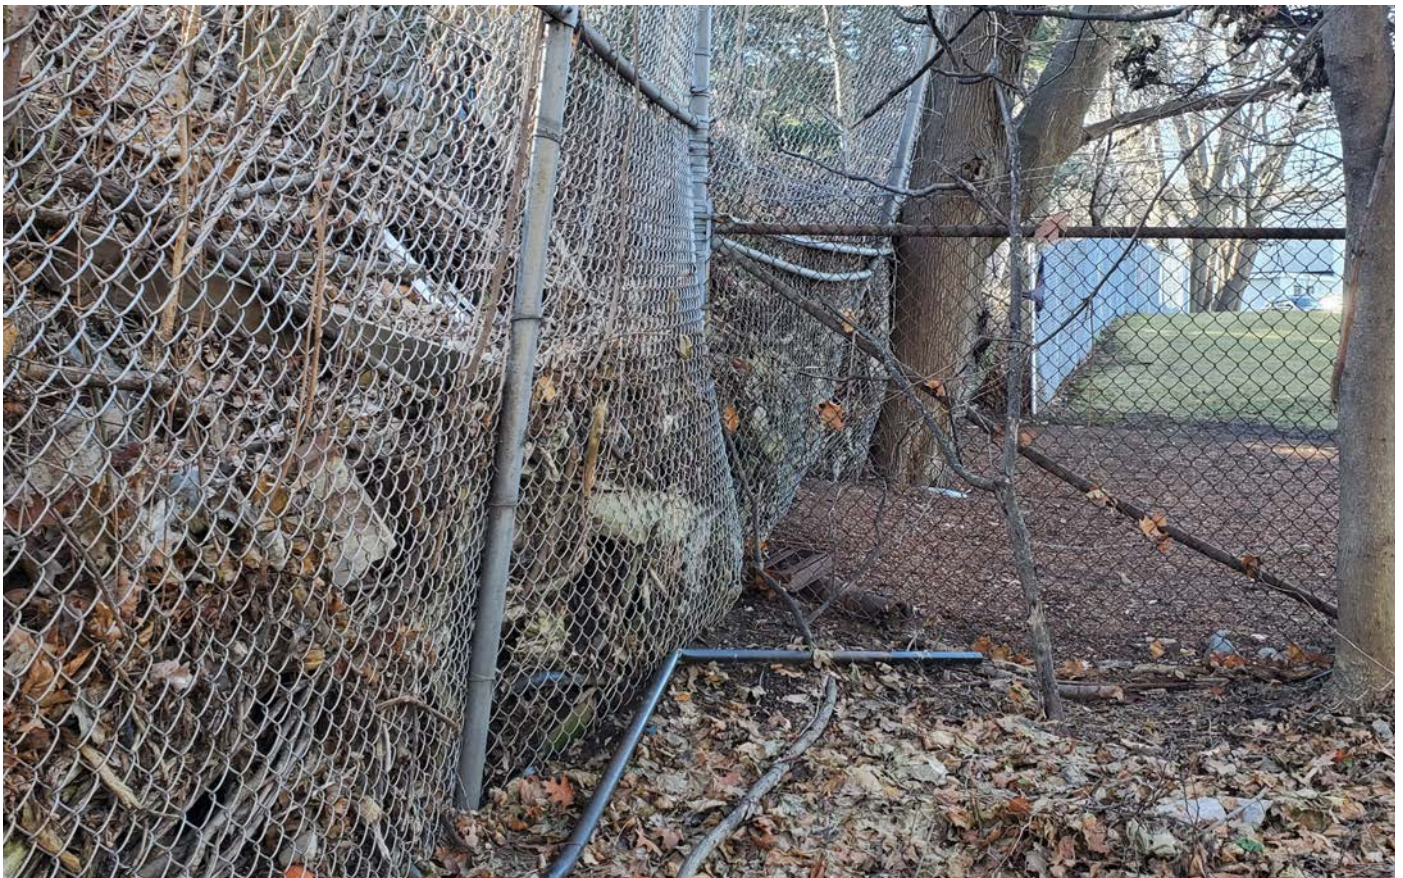
4 Chain Link Fence with Barbed Wire (Southern Edge at Ball Field)

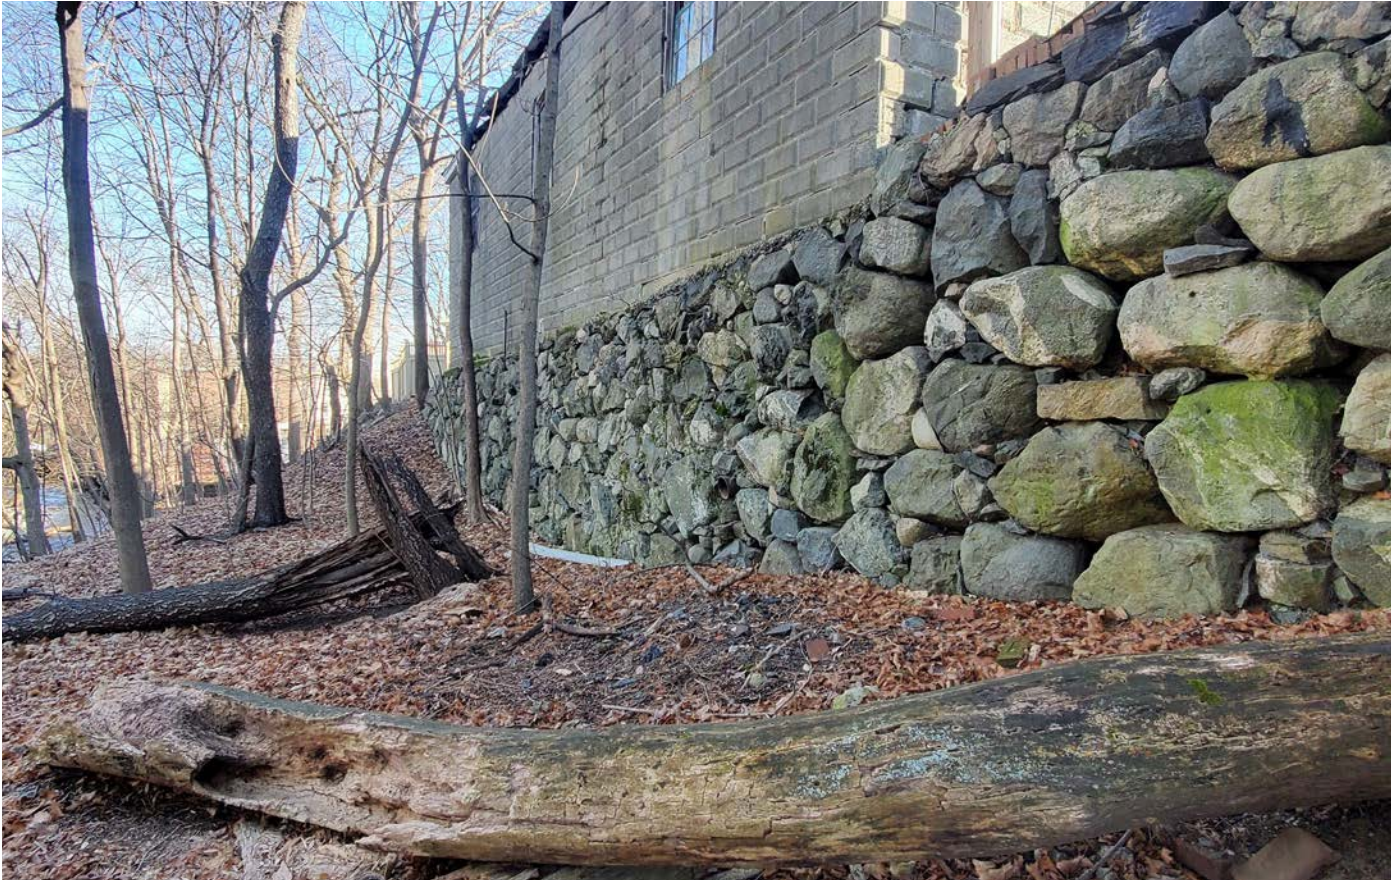
5 Stone Retaining Wall (Southwest Corner of Site Above Slope)

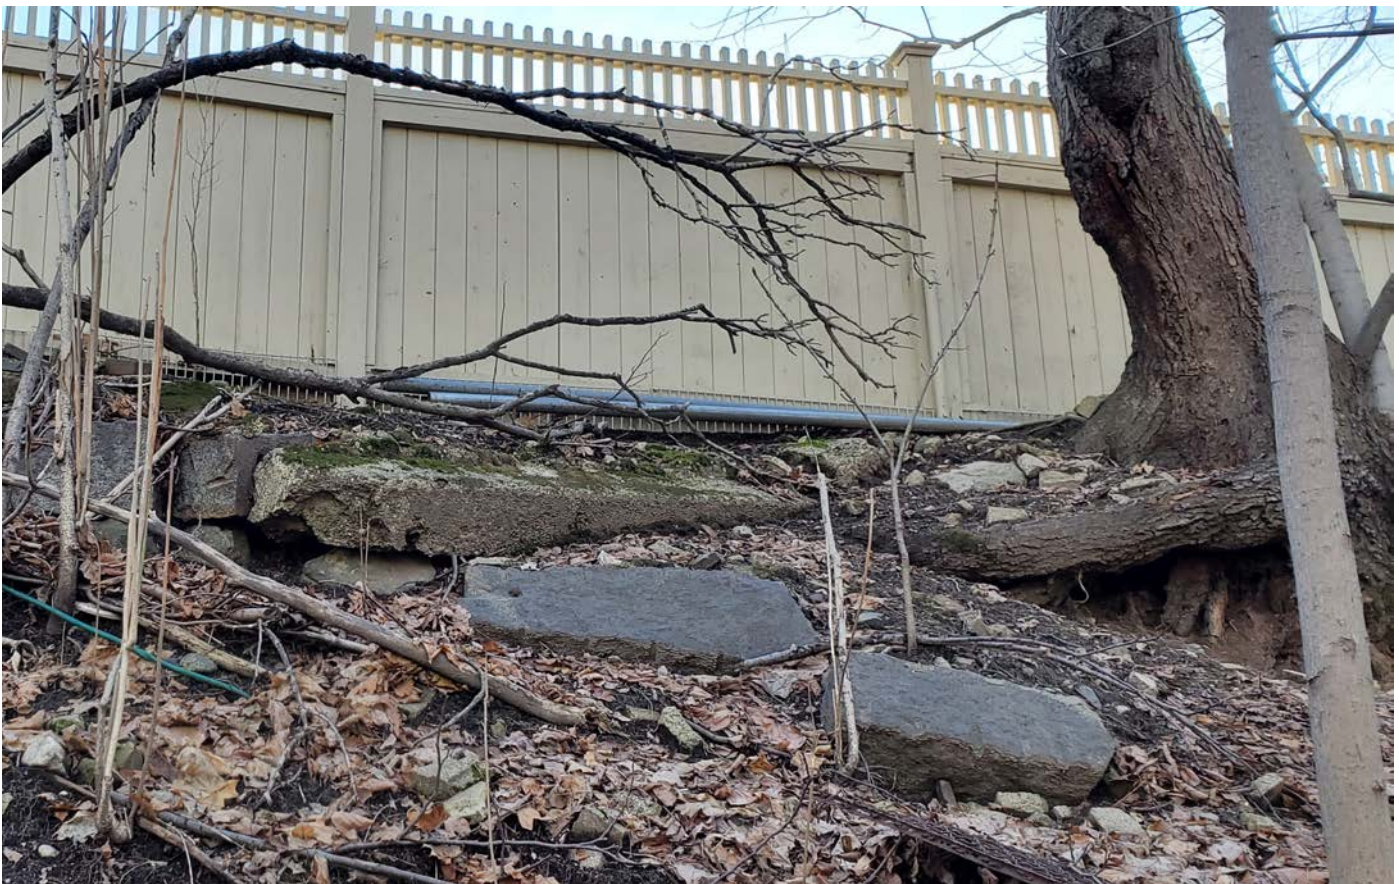
6 Wood Privacy Fence (Along Southern Top of Slope Edge)

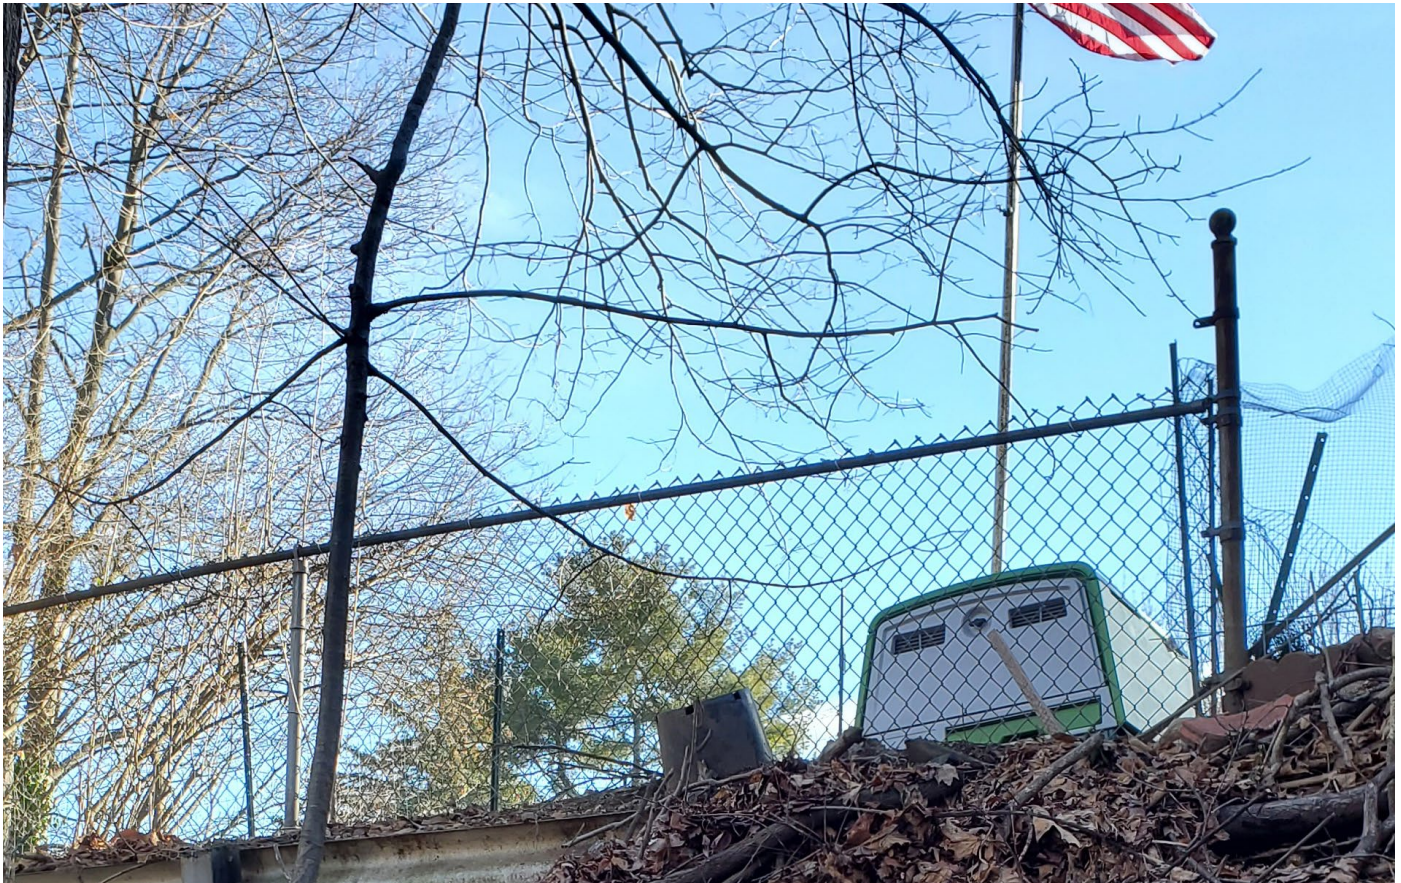
7 6' Chain Link Fence (Along Southern Top of Slope Edge)

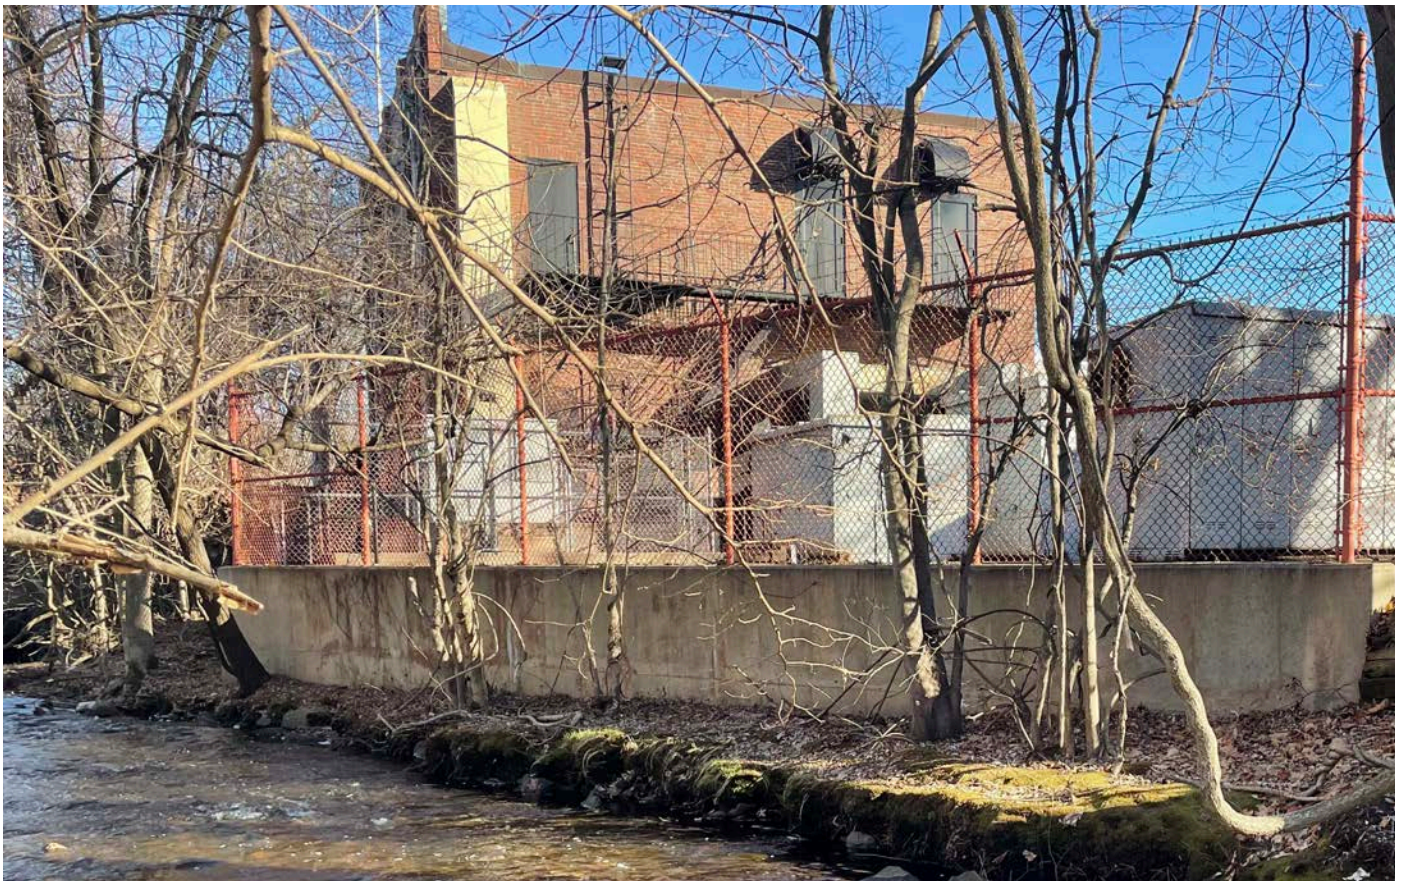
8 Retaining Wall and Chain Link Fence with Barbed Wire at Eversource

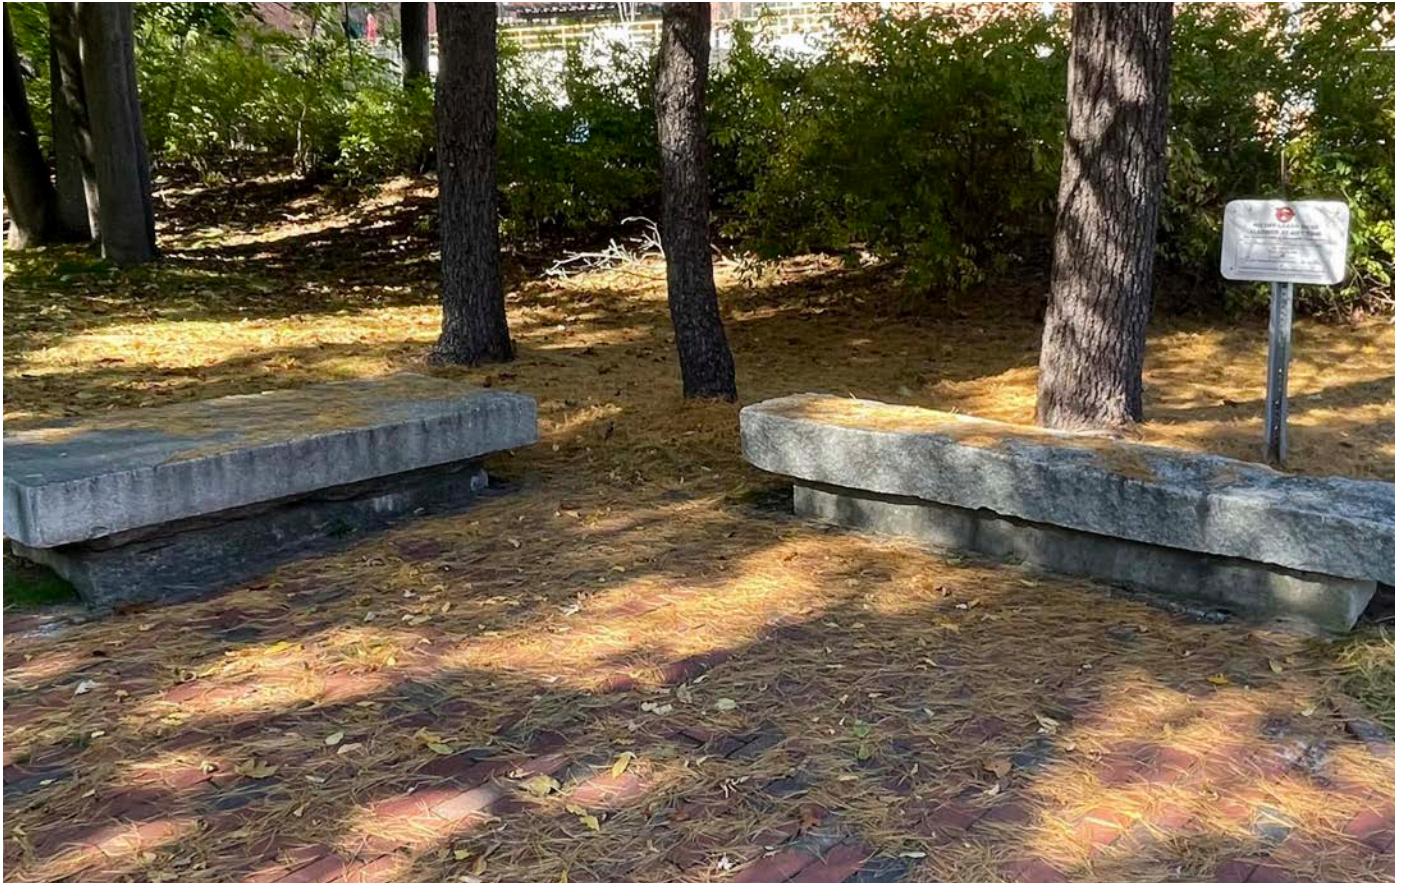
1 Granite Slab Benches

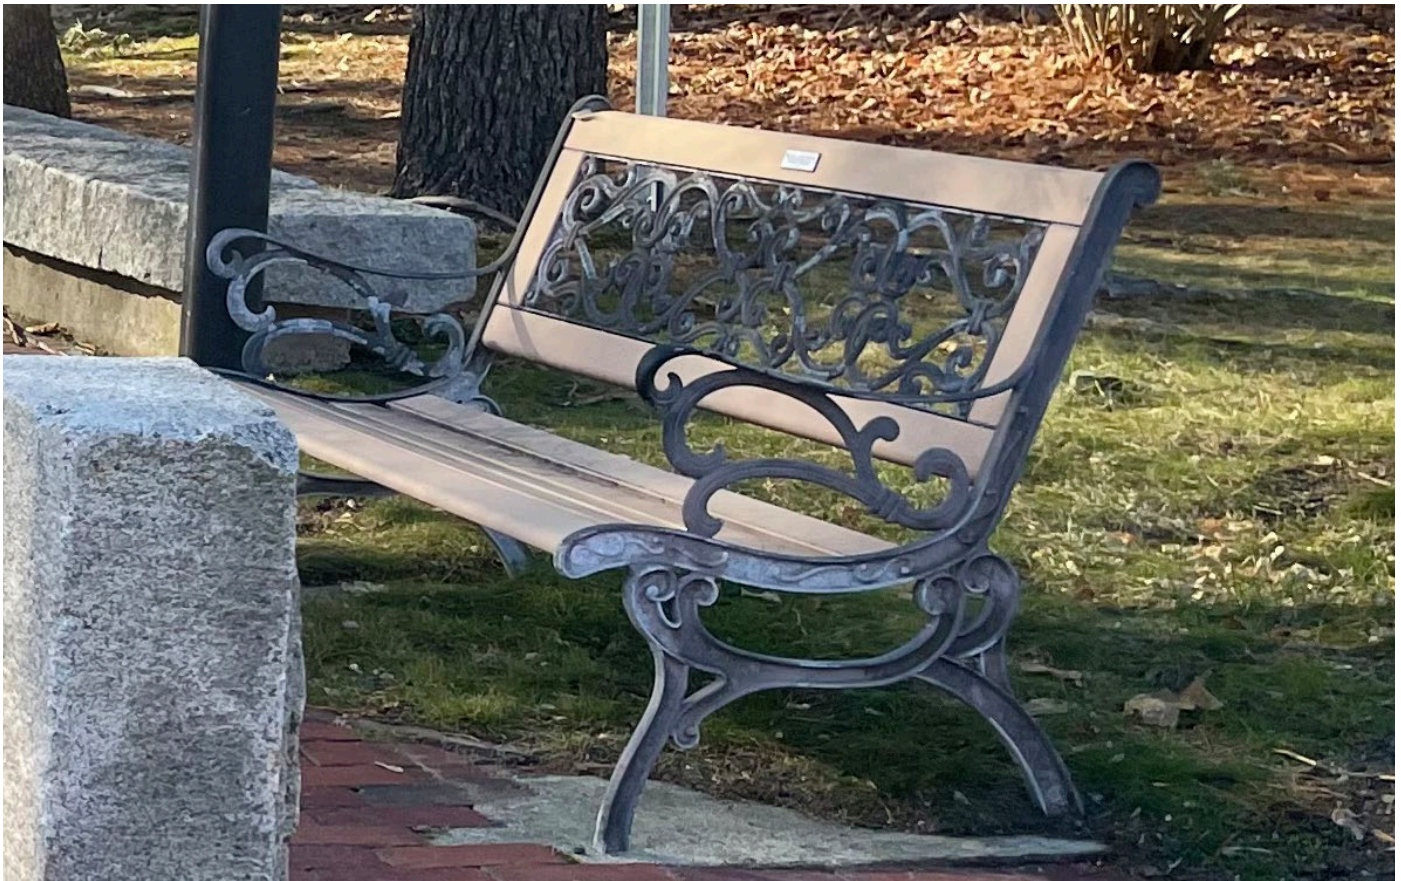
2 Composite Wood and Metal Bench at Mystic Street Entrance

- i. Replace existing plastic bench with timber and steel Town standard (Arlington Reservoir example).
- j. Lighting at Cusack Terrace identified as intrusive; consider moderate lighting along path and base of falls.

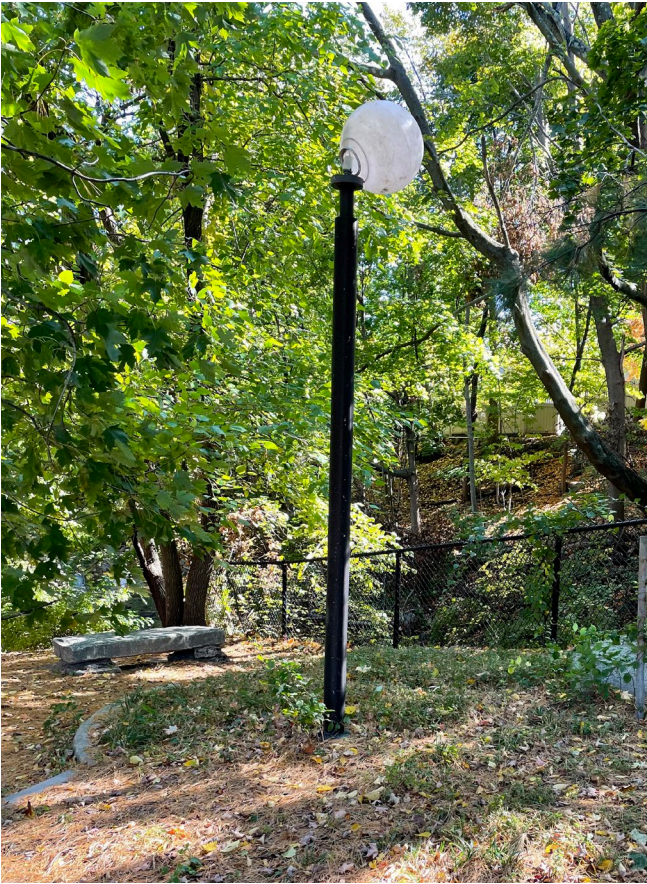
3 Globe Light Pole Fixture

- c. Light fixtures are broken and not aesthetically pleasing in character/design; as a Conservation Commission property, the park is technically open only from dusk to dawn.

1. NEW SITE FURNISHINGS: BIKE RACKS AND NEW TRASH / RECYCLING RECEPTACLES.
2. SUBDUED PARK ENTRY; RELOCATE GRANITE BENCHES AND COOKE'S HOLLOW ENTRY PLAQUE NEAR FALLS, GRANITE ENTRY BOLLARDS TO REMAIN.
3. EXISTING SITE LIGHTING TO BE REMOVED; NO SITE LIGHTING PROPOSED WITHIN THE PARK.
4. RELOCATE COOKE'S HOLLOW BOULDER PLAQUE AND GRANITE BENCHES WITHIN VIEW OF THE FALLS.
5. NEW BLACK IRON RAILING (CONTEMPORARY STYLE) ABOVE FALLS.
6. BLACK VINYL CHAIN LINK FENCE ALONG BALL FIELD EDGE.
7. PICNIC AREA SHIFTED TOWARDS FALLS (EXISTING PICNIC TABLES RESET).

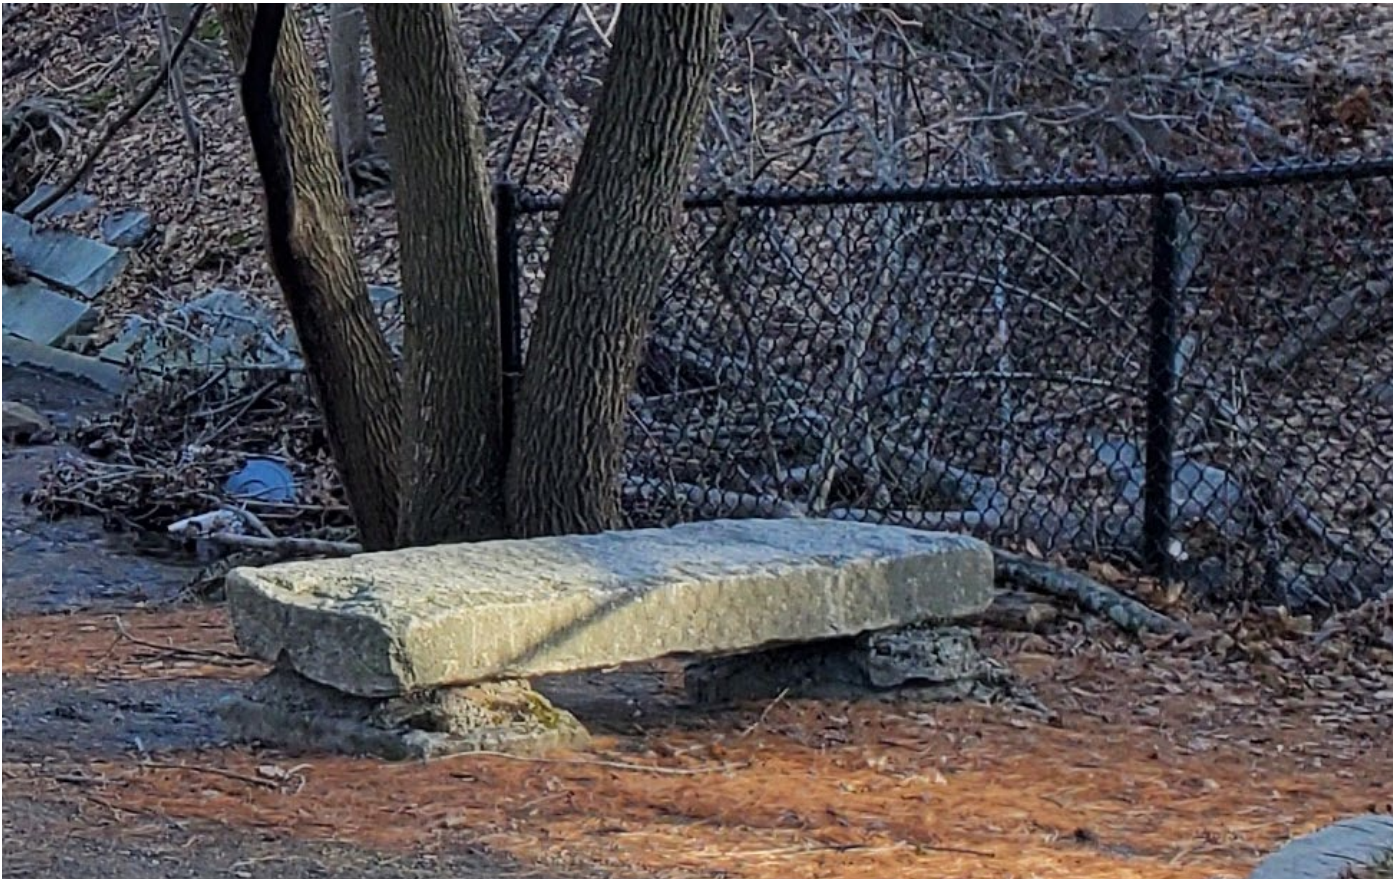
4 Granite Slab Bench Above Stairs
